## 20. THE CEILINGS AND THE CHANDELIERS

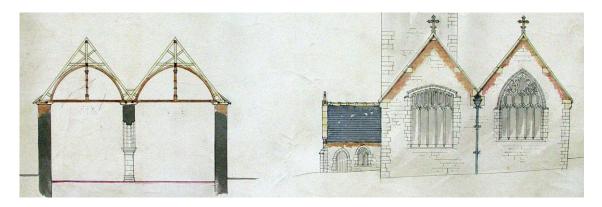
Above is Seddon's plan of his roof alterations, looking from the east of the church. Before 1870 the roofs of the chancel/nave and the north aisle were not of equal heights, and the 1849 watercolour (below) by Charles Walker shows this well, and also a scar on the tower wall which indicates the height of a former roof.
