10. THE ORGAN CHAMBER

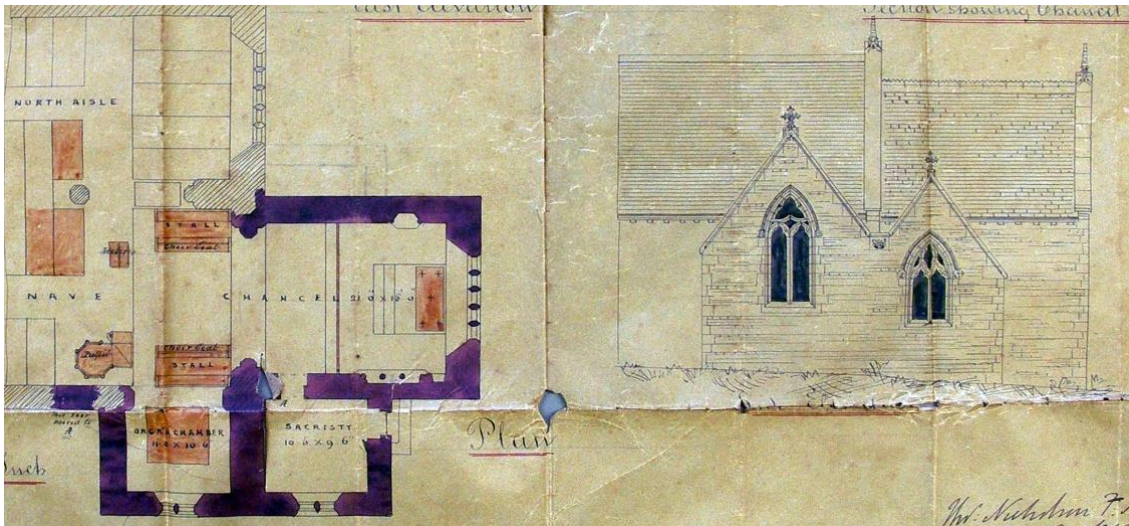
A plan was drawn up by Thomas Nicholson in 1876 to extend the chancel further to the east, shown in purple on the plan. This would have allowed both an organ chamber and a sacristy - a room for the priest to dress and where vestments were kept - to be fitted in on the south side. This was probably too expensive so the sacristy was abandoned; the chancel stayed the same but the organ chamber *was* built, see the south (left) and east faces below .

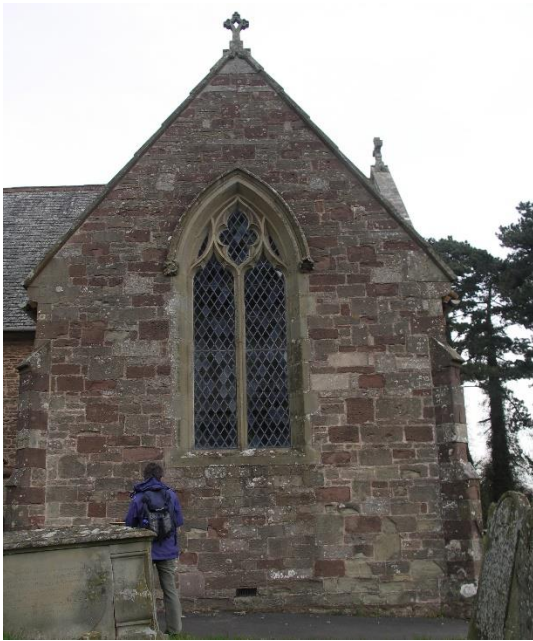
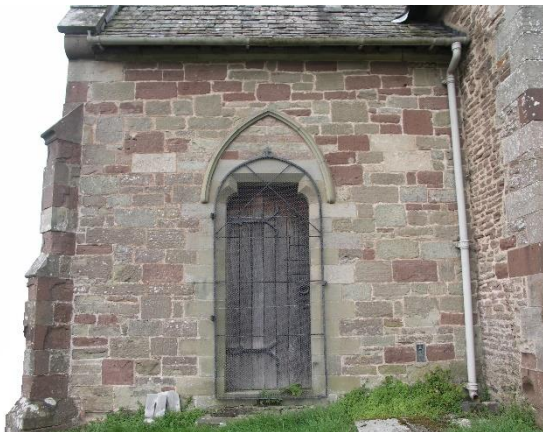
The organ chamber is connected to the church by a massive arch - so large perhaps the stones for the new chancel arch had already been made and had to be used. In the process it destroyed the original priest's entrance to the church and a window to the east. The priest now had to enter by the door on the east side of the organ chamber and squeeze past the organ into the church. This door is locked and probably hasn't been used for many years.
